BELZONA REINFORCES AND PROTECTS TURBINE

ID: 5323

Customer Location: MO, USA
 Application Date: October, 2004

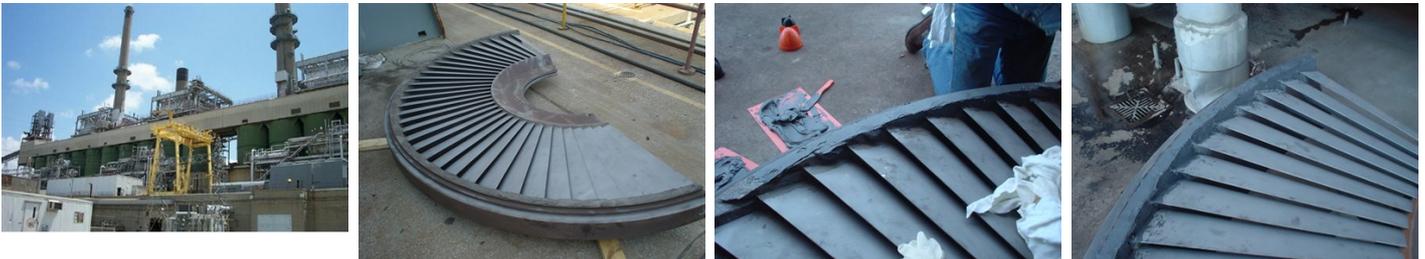
Photograph Descriptions

The GE Turbine was partially disassembled for inspection. 7th stage blades being replaced in HP turbine section. Stationary diaphragms of last two stages of LP turbine section were removed for inspection and it was determined that they had been rebuilt with Belzona 1311 two outages prior (16 years ago!). The customer wanted to ensure many more years of service.

- * Overview of the Power Plant ,
- * Stationary diaphragms removed for inspection ,
- * Blades showed signs of erosion so they were rebuilt ,
- * Application carried out for all four diaphragm halves showing one of the four finished repairs ,

Only one power pack of Belzona 1311 was needed to repair four diaphragm halves and four casing bells. The application was carried out in accordance with Belzona Know-How System Leaflet CEP-1.

Following inspection from a scheduled outage for the plant confirmed that the GE Turbine that previously applied Belzona 1311 on the equipment had held up for 13 years! The customer elected to rehab same repairs! The application was accomplished in one day, start to finish, and did not negatively impact the planned outage by causing any further delay. Belzona 1311 had held up remarkably

well, but all parties made the decision to blast off the existing Belzona that remained on the diaphragms and re-apply Belzona 1311 to ensure many more years of service.
