BELZONA REINFORCES AND PROTECTS TURBINE

ID: 5323

Application: CEP-Centrifugal Pumps

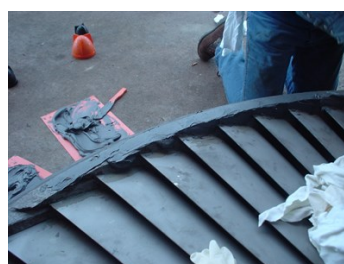
The GE Turbine was partially disassembled for inspection. 7th stage blades being replaced in HP turbine section. Stationary diaphragms of last two stages of LP turbine section were removed for inspection and it was determined that they had been rebuilt with Belzona 1311 two outages prior (16 years ago!). The customer wanted to ensure many more years of service.

- * Overview of the Power Plant ,
- * Stationary diaphragms removed for inspection ,
- * Blades showed signs of erosion so they were rebuilt ,
- * Application carried out for all four diaphragm halves showing one of the four finished repairs ,

Only one power pack of Belzona 1311 was needed to repair four diaphragm halves and four casing bells. The application was carried out in accordance with Belzona Know-How System Leaflet CEP-1.
