# BELZONA REPAIRS A DAMAGED SHAFT

ID: 5324

Industry: *Mining & Quarrying*  
Application: *MPT-Mechanical Power Transmission*

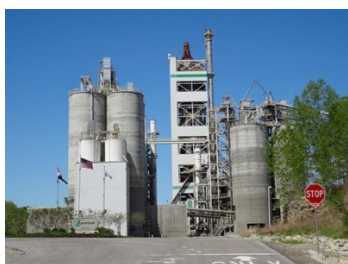
- \* Overview of the Plant ,
- \* Rock crusher platform ,
- \* Damaged rock crusher shaft ,
- \* Completed application on the shaft ,

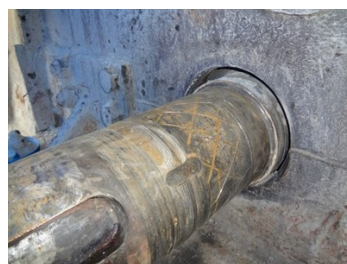
*During the bearing replacement on the rock crusher of this large quarry operation, it was noted that the shaft had been worn undersized.*

A trained machine shop fabricated a split former to exact dimensions and the shaft was quickly repaired in-situ with Belzona 1111. The application was carried out in accordance with Belzona Know-How System Leaflet MPT-2.
