# A Durable Belzona Coating for Conveyor

ID: 533

Industry: *General Industry*  
Application: *SHM-Solids Handling Machinery*

Customer Location: *Chipboard manufacturer - UK*  
Application Date: *February 2005*

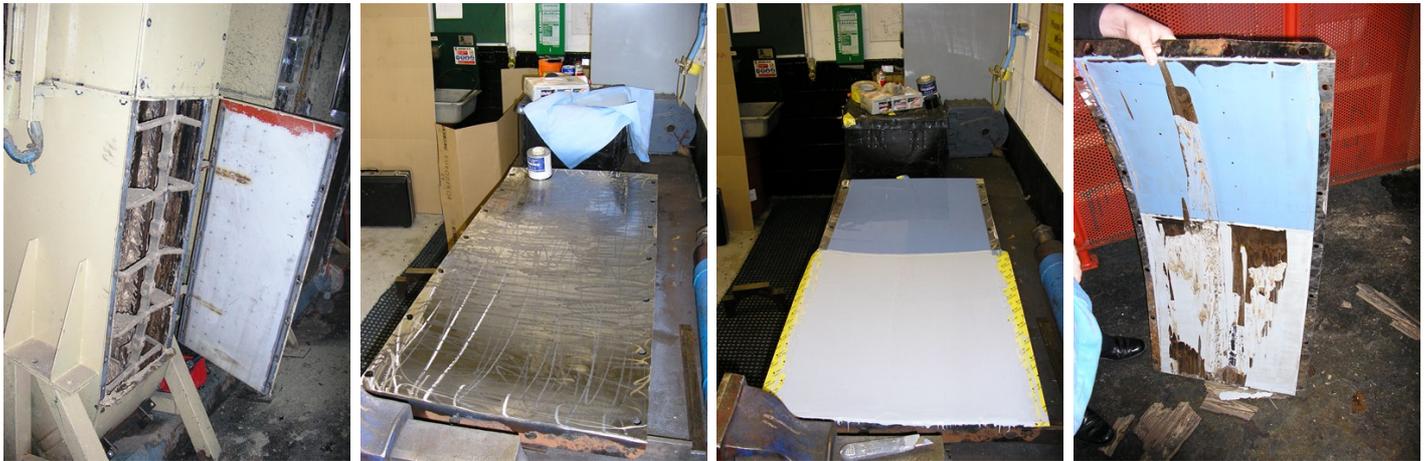
## Photograph Descriptions

*Conveyor suffering build up of product causing flights to drive up into conveyor ceiling. Customer sought to reduce the excessive maintenance down time through the use of Belzona.*

- \* Conveyor with product build-up clear to see ,
- \* Plate prepared for application of product ,
- \* Product applied to conveyor bottom ,
- \* Conveyor bottom removed to prove performance of Belzona® 1341 ,

Application was carried out using a modified version of Belzona Know-How System Leaflet SHM-13.

Since application of Belzona® 1341, the issue of build-up on the conveyor has been stopped - putting an end to time consuming maintenance that was carried out every five weeks and took four maintenance personnel. This also increased potential production time on this piece of plant equipment.
