BELZONA OFFERS PROTECTION BY SEALING INSULATOR BASES

ID: 5331

Customer Location: Montana, USA
Application Date: 1986

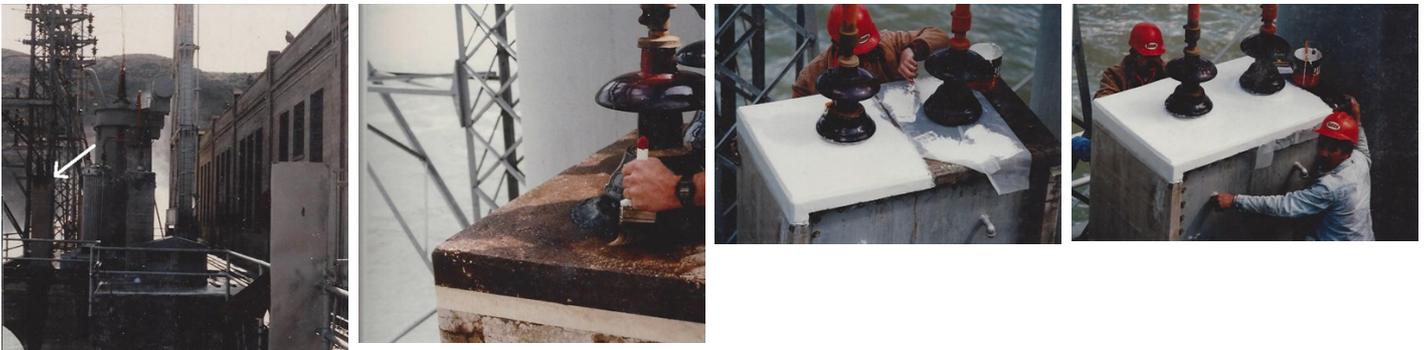
Photograph Descriptions

The bases of the insulators had been sealed and re-sealed many times but it never lasted long, thus water would begin to leak through the base. The switch gear below carries 100,000 volts of electricity which would not react well if the water hit the wrong spot.

- * Arrow shows damaged area ,
- * Applying Belzona 3911 ,
- * Brushing on reinforced Belzona 3111 ,
- * Brushing on reinforced Belzona 3111 ,

Loose tar was removed. Belzona 3911 was brushed on the concrete and Belzona 3921 was brushed on the insulator. Two coats of Belzona 3111 were brushed on, incorporating reinforcing sheet in the first coat. The application was carried out in accordance with a modified version of Belzona Know-How System Leaflet GSS-3.
