BELZONA EXTENDS THE LIFE OF THE ROOF

ID: 5332

Customer Location: *Great Falls, MT, USA*
Application Date: *1986*

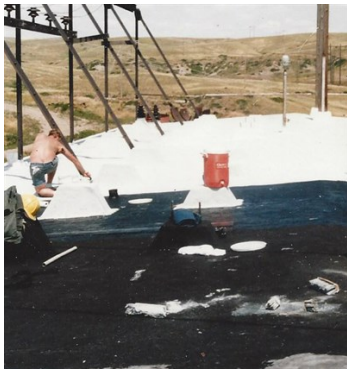
This roof had leaked for as long as they could remember. One person speculated that it had probably leaked since it had been built, which was 1906. You can see the many protrusions through the roof, making it difficult to seal with conventional roofing products. Currently, the hot-mopped tar on the roof was seriously "alligatored".

- * Roof half done, showing the complicated design and many protrusions ,
- * Belzona 9311 laid out and brushing on Belzona 3111 ,
- * & 4. Completed application ,

The power was cut to sections of the roof where we worked. The roof was dry brushed to remove dirt in the alligator cracks. Because the lines below the roof and overhead carried high voltage electricity, we were not allowed to use water. Belzona 3911 was brushed and rolled on all tar areas while Belzona 3921 was applied to the prepared metal bases, insulators and copper flashings around the roof edges. Belzona 9311 was laid out and the first coat of Belzona 3111 was applied with long handle brushes. The

second coat was brushed on the same day. The work began at one end of the roof taking 5 days to complete the job. Temperatures were over 100F on the roof. It is now 2014 and the roof has been leak free for 28 years. The application was carried out in accordance with Belzona Know-How System Leaflets RPA-1, RPA-6 & RPA-8.
