# BELZONA PROTECTS DIESEL FUEL BAY WITH NON-SKID FLOORS

ID: 5333

Fuel bay floor at bus depot.

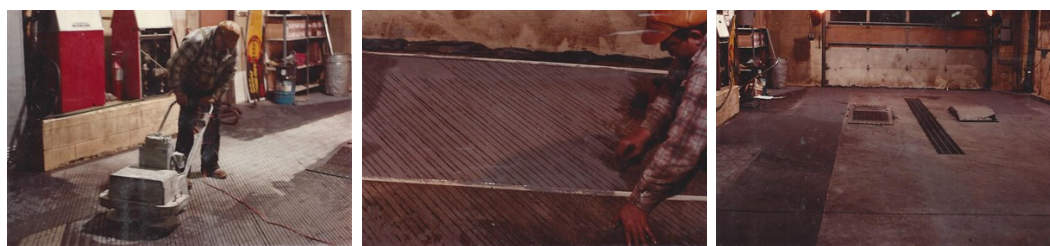
*Diesel spilled on the concrete floor was causing slip problems. The diesel had been soaking into the concrete for over 10 years and nothing would stick to the surface.*

- \* Grinding the surface with a stone grinder ,
- \* Brushing on Belzona 4411 ,
- \* Completed application of test patch ,

The floor was pressure washed to remove the remainder of previous non-skid products and the spilled diesel fuel. A propane torch was used to lightly heat the concrete, drawing out more diesel fuel from the concrete. The floor was pressure washed a second time. A stone floor grinder was used to remove the surface laitance then Belzona 4411 was brushed on, sprinkling aggregate on top. The application was carried out in accordance with Belzona Know-How System Leaflet FPA-8.

This was a "test patch" as the owner had seen every product he could find fail within weeks of the applications. One year later, Belzona 4411 was in perfect condition. The entire fuel bay floor was then coated with Belzona 4411.
