BELZONA SAVES A ROOF EXPANSION JOINT

ID: 5338

Roof Expansion Joint

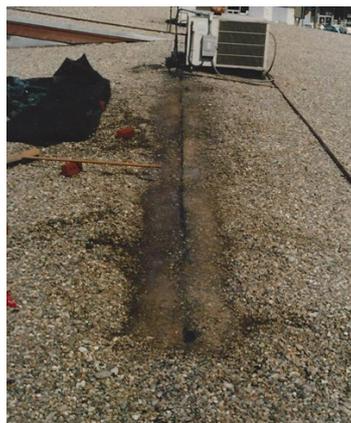
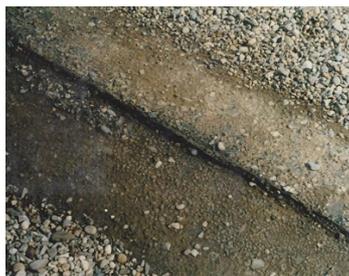
The expansion joint on the roof of a bowling alley had split open, caused by movement through temperature variations.

- * & 2. With the pea gravel removed the problem is obvious ,
- * Problem solved. ,

The owner was planning to re-tar the entire roof, as recommended by the local roof contractor. Just part of one bucket of reinforced Belzona 3111 solved the problem with the building owner doing the application himself.
