# BELZONA SAVES A ROOF EXPANSION JOINT

ID: 5338

Roof Expansion Joint

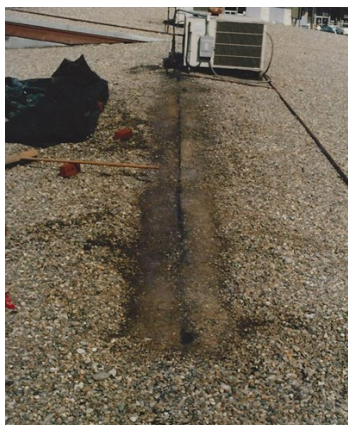
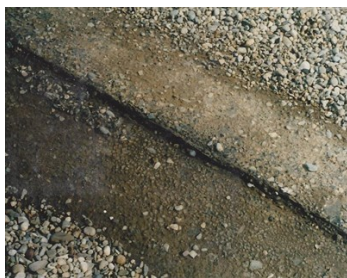
*The expansion joint on the roof of a bowling alley had split open, caused by movement through temperature variations.*

- \* & 2. With the pea gravel removed the problem is obvious ,
- \* Problem solved. ,

The application was carried out in accordance with Belzona System Leaflet RPA-1.

The owner was planning to re-tar the entire roof, as recommended by the local roof contractor. Just part of one bucket of reinforced Belzona 3111 solved the problem with the building owner doing the application himself.
