BELZONA PROVIDES SAVINGS BY SEALING FLOOR

ID: 5349

Industry: Buildings & Structures
Application: FPA-Floor Problem Areas
Substrate: Urethane
Products: * Belzona 2221 (MP Fluid Elastomer) ,
* Belzona 2911 (Elastomer QD Conditioner) ,
* Belzona 9341 (Reinforcing Sheet) ,

Customer Location: WA, USA
Application Date: 1992

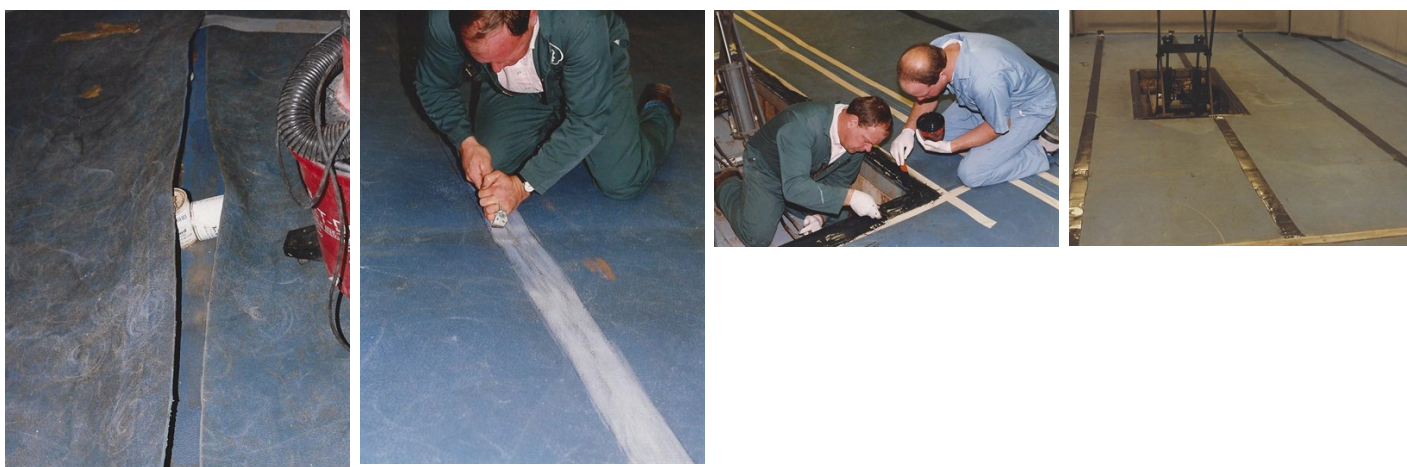
Photograph Descriptions

The seams on the floor in the large animal surgery room had split open, allowing bacteria to flourish underneath. The floor had to be sealed.

- * Drying the floor after cleaning ,
- * Abrading the surface ,
- * Applying Belzona 2221 over the seams ,
- * Completed application ,

The floor was cleaned and disinfected, and then allowed to dry. A roughing tool was used to abrade the surface. Belzona 2911 was applied and allowed to cure. The area was masked off and Belzona 2221 was brushed on with Belzona 9341 to bridge the seam. The application was carried out in accordance with a modified version of Belzona Know-How System Leaflet FPA-6.
