Rig Ballast System Repaired with Belzona

ID: 535

Application: VPF-Valves, Pipes and Fittings

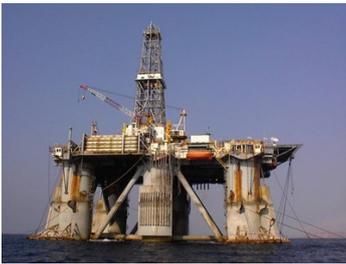
Severely corroded and leaking pipes in many sections of the ballast system which threaten the safety of the rig.

- * General view of the rig ,
- * Leakage of the ballast pipes of the rig ,
- * Repair completed ,
- * Another repair ,

Application was carried out in accordance with Belzona Know-How System Leaflet VPF-11a.
