BELZONA REPAIRS AND PROTECTS CHIPPER DISC POCKETS

ID: 5351

Industry: *Pulp & Paper*

Application: *SHM-Solids Handling Machinery*

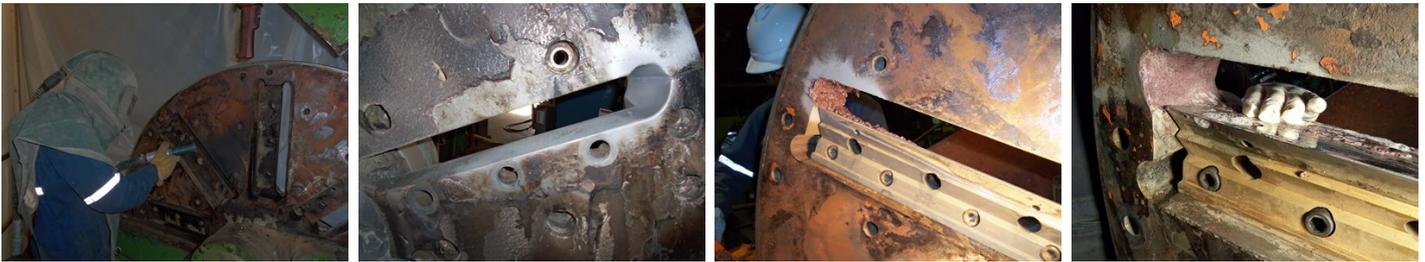
Photograph Descriptions

Excessive wear in the chipper disc pockets was damaging the chips.

- * Grit blasting the chipper disc pockets ,
- * Pocket ready for application of Belzona 1811 ,
- * Pocket from front side showing counter knife in place, Belzona 1811 in the pocket ,
- * Smoothing Belzona 1811 with soap and water to prevent chips from sticking ,

The chipper disc pockets were sweated and grit blasted in place. Belzona 9411 was brushed onto the new counter knives. The counter knives were installed and Belzona 1811 was applied in the pockets. After a partial cure, water mixed with dish soap was used to smooth the surface so the wood chips would not clog the pockets. The application was carried out in accordance with Belzona Know-How System Leaflet SHM-13.
