# BELZONA PROTECTS STERN TUBE

ID: 5353

Stern tube in a US Army Ship.

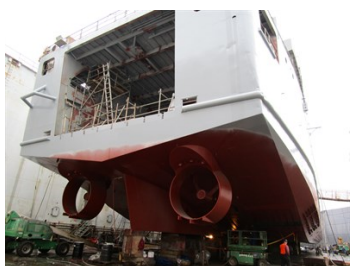
- \* Stern of the ship ,
- \* Inspecting the grit blast ,
- \* First coat of black Belzona 5811 ,
- \* Second coat of gray Belzona 5811 ,
