# BELZONA PROTECTS STERN TUBE

ID: 5353

Industry: *Marine*  
Application: *SOS-Ships and Offshore Structures*

Stern tube in a US Army Ship.

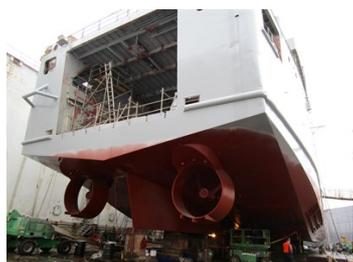
*The US Army required standard protection against erosion and corrosion when the ship is dry docked.*

- \* Stern of the ship ,
- \* Inspecting the grit blast ,
- \* First coat of black Belzona 5811 ,
- \* Second coat of gray Belzona 5811 ,

The stern tube was grit blasted and then two coats of Belzona 5811 were brushed on. The application was carried out in accordance with Belzona Know-How System Leaflet SOS-2.
