BELZONA SAVES TUG BOAT COMPANY \$200,000+

ID: 5354

Industry: *Marine*
Application: *SOS-Ships and Offshore Structures*

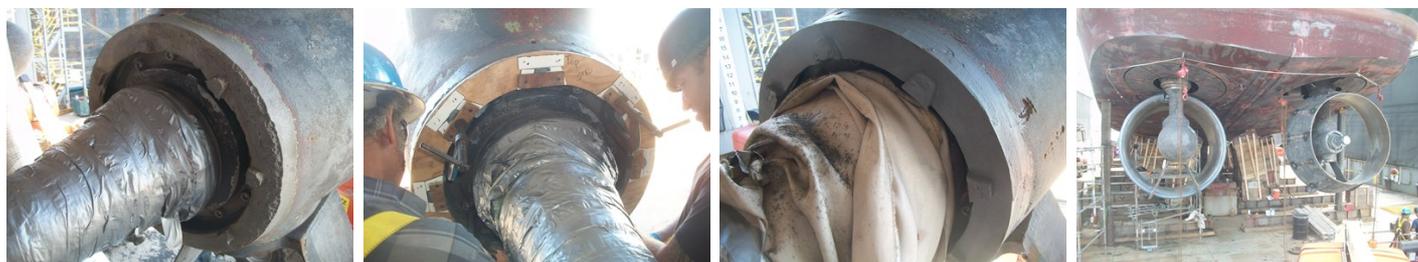
Photograph Descriptions

While in dry dock, it was found that the lower half of the port and starboard Kort nozzle drive assemblies had severe erosion on the propeller side of the housing.

- * Eroded housing ,
- * Belzona 1311 applied and the former installed ,
- * Repair completed ,
- * The Port and Starboard Kort nozzles and drive assemblies shown while the tug is in dry dock ,

The housings were blasted to a near white metal and were checked for chlorides. Plywood formers were made to ensure the original shape of the housings were restored. A release agent was applied to the formers. A generous amount of Belzona 1311 was applied to the housing. The formers were immediately installed and the excess of Belzona 1311 was faired smooth, even with the former, and tapering to the housing.

Also, while using Belzona 1311 to complete the repair, the owner was able to widen the diameter of the housing a half inch so that it has a more hydrodynamic water flow around hub of the propeller.
