# BELZONA REPAIRS HOLES IN US NAVY SHIP

Industry: *Marine*  
Application: *TCC-Tanks and Chemical Containment Areas*

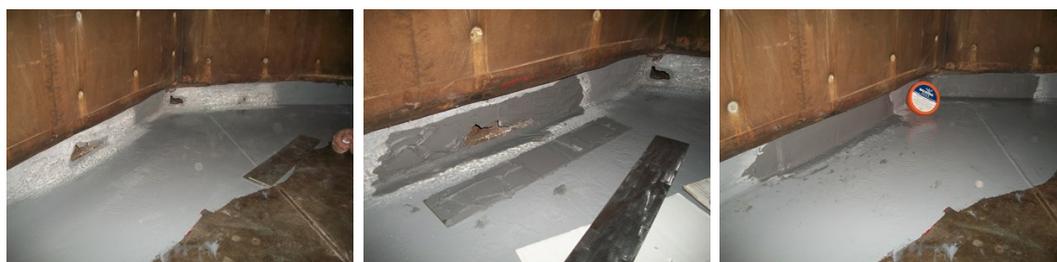
*The bulkhead in the intake plenum has holes rusted through the steel.*

- \* Three holes are shown in the intake plenum. Two large and one small. ,
- \* A thorough grinding of the bulkhead and the steel plates is completed. ,
- \* The completed repair is shown. Belzona 1111 was used to bond the plates over the holes. ,

The application was carried out in accordance to a modified version of Belzona Know-How System Leaflet TCC-1. The bulkhead and steel were thoroughly grinded to prepare the surface. Steel doubler plates were bonded over the holes with Belzona 1111.

Belzona was the only fast and effective solution to the problem. Welding was not allowed. The application was completed without using hot work thanks to Belzona 1111's cold bonding properties.
