# BELZONA REPAIRS TORN RIB BOAT SPONSON

ID: 5356

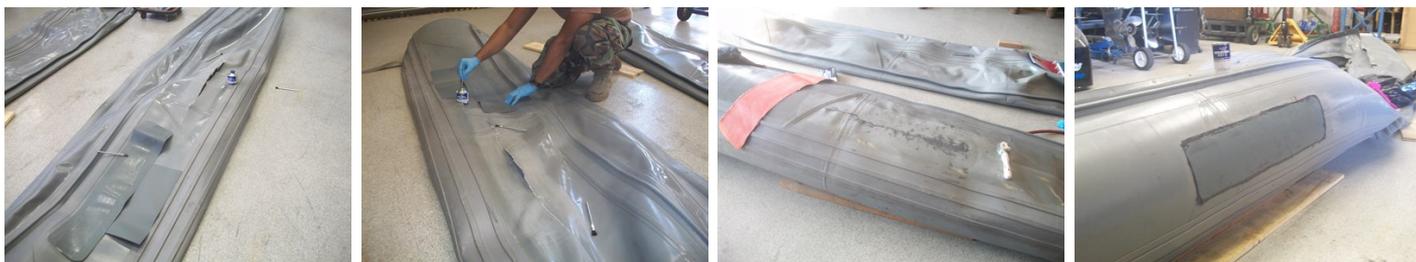
The sponson has an 18 inch long tear.

- \* 18 inch long tear in the inflatable sponson of a Navy RIB boat ,
- \* The repair area of the sponson and repair patches have been thoroughly roughened. ,
- \* The inside patch bonded in place. ,
- \* The outside patch bonded in place and the section of the sponson is shown inflated and holding air. ,

Two pieces of synthetic rubber were cut to bond over the hole. Roughened the inside and outside surfaces of the sponson as well as the repair patches. Bonded the inside patch using Belzona 2211 and then bonded the second patch on the outside. Pressure was added to both patches during their cure time.
