BELZONA REPAIRS PURGE TANK

ID: 5358

Industry: *General Industry*
Application: *TCC-Tanks and Chemical Containment Areas*
Substrate: *Carbon Steel*
Products: ** Belzona 1511 (Super HT-Metal),
* Belzona 5892 ,*

Customer Location: *South Florida, USA*
Application Date: *May 2014*

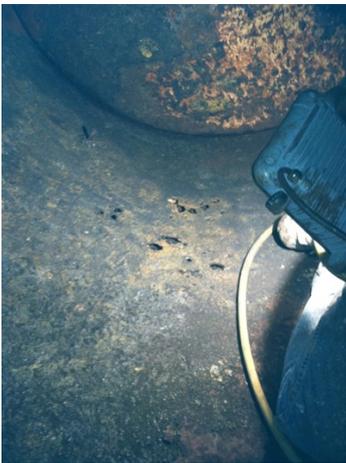
A purge tank was getting corroded to the point that hot water was seeping through small holes in the tank. Leakage and safety were a great concern.

- * Condition of the tank ,
- * Tank after grit-blasting ,
- * Bonding metal patches using Belzona 1511 ,
- * View of the tank after two coats of Belzona 5892 ,
