BELZONA REPAIRS PURGE TANK

ID: 5358

Industry: *General Industry*
Application: *TCC-Tanks and Chemical Containment Areas*
Substrate: *Carbon Steel*
Products: ** Belzona 1511 (Super HT-Metal) ,*
** Belzona 5892 ,*

Customer Location: *South Florida, USA*
Application Date: *May 2014*

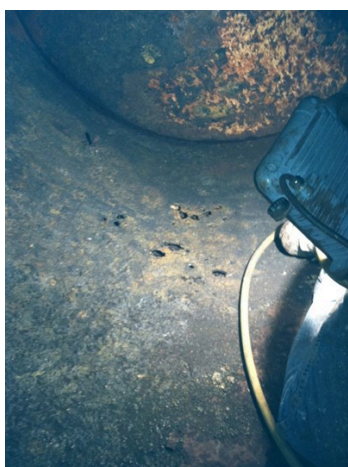
A purge tank was getting corroded to the point that hot water was seeping through small holes in the tank. Leakage and safety were a great concern.

- * Condition of the tank ,
- * Tank after grit-blasting ,
- * Bonding metal patches using Belzona 1511 ,
- * View of the tank after two coats of Belzona 5892 ,
