# BELZONA REPAIRS NAVY VALVE

Industry: *Military*  
Application: *ENC-Engines and Casings*  
Substrate: *Bronze*  
Products: *\* Belzona 1111 (Super Metal) ,*  
*\* Belzona 9411 (Release Agent) ,*

Customer Location: *VA, USA*  
Application Date: *2011*

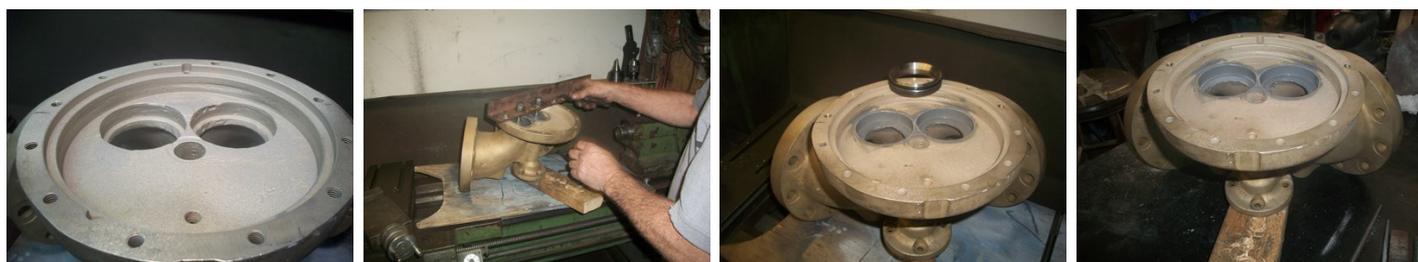
*The bronze substrate had eroded in the valve seating area to the point where the rubber O-ring could no longer seal.*

- \* Bronze valve casing eroded in the seat O-ring area ,
- \* Formers seated in Belzona 1111 to mold a smooth oil seal surface ,
- \* Newly molded O-ring surfaces. Also, a new valve seat with O-ring is shown as well ,
- \* Left newly molded area with the excess of Belzona 1111 filed away using round rasp files ,

The bronze valve housing was blasted to a near white metal finish. Dummy valve seats were manufactured and coated with Belzona 9411 to serve as formers. Belzona 1111 was applied to the blasted housing and to the formers. The formers were seated into the fresh Belzona 1111. Several hours later the formers were removed and the excess of Belzona 1111 was removed using coarse files.
