# BELZONA EXTENDS THE LIFE OF HYDRAULIC RAMS

ID: 5364

Industry: *Pulp & Paper*  
Application: *MPT-Mechanical Power Transmission*

Customer Location: *WA, USA*  
Application Date: *1985*

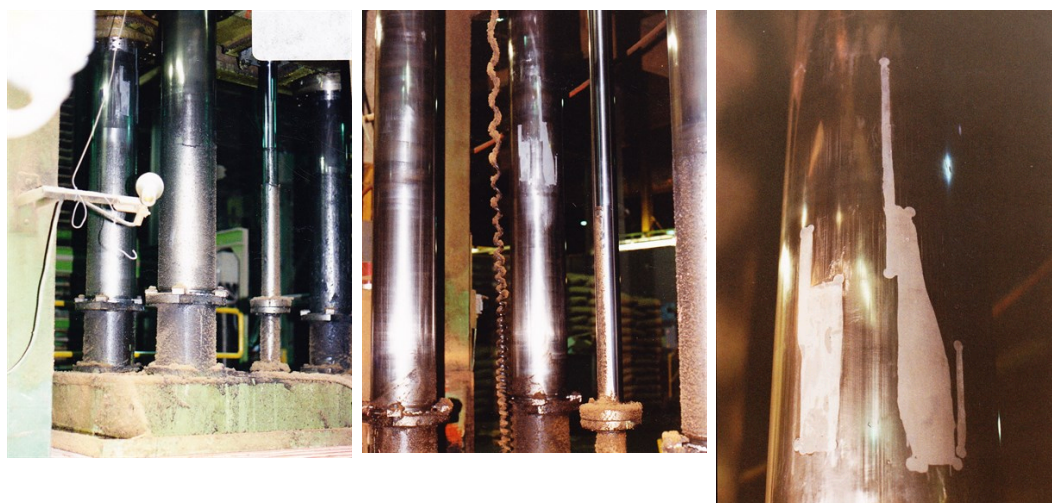
*Three hydraulic rams had been scored and the loss of oil was so bad that they had built a dam so the oil would drain into a 55 gallon drum. At the end of each shift the oil was pumped back into the reservoir. They had tried repairing the score with another material, but it fell off after one pass.*

- \* Plywood press showing damaged hydraulic rams ,
- \* Rams repaired ,
- \* Close up of one repaired ram ,

Plywood press with scored hydraulic rams.

The application was carried out in accordance with Belzona Know-How System Leaflet MPT-3. The damaged area was so large that a straight edge could not be used. We ground a shoulder following the damage, drilling the corners to keep the edges square.

Fabricating new rams was so expensive that they were searching for a used plywood press to replace the unit. Still, the cost would be thousands of dollars. Less than \$100.00 of Belzona 1111 along with a half a day's labor saved the plywood press. Thirty years later, the plywood press with the repaired rams is still operating.
