BELZONA REBUILDS PUMP IMPELLER

Application: CEP-Centrifugal Pumps

Circulating water pump in a potato processing plant.

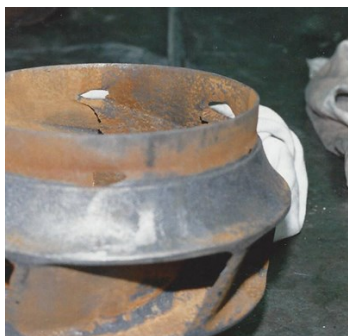
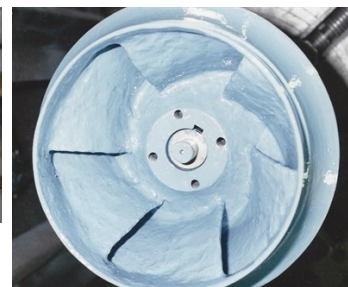
Photograph Descriptions

The pump had become worn beyond repair and was thus tossed in a scrap pile.

- * Damaged impeller showing holes ,
- * Worn impeller vanes ,
- * Impeller rebuilt with Belzona 1311 ,
- * Completed application with two coats of Belzona 1341 ,

The application was carried out in accordance with Belzona Know-How System Leaflets CEP 1 & CEP 3. Holes and impeller vanes were patched with Belzona 1311 and a reinforcing sheet. The high spots were ground down to smooth the surface and Belzona 1341 was brushed on in two coats.
