BELZONA REBUILDS PUMP IMPELLER

Application: *CEP-Centrifugal Pumps*

Circulating water pump in a potato processing plant.

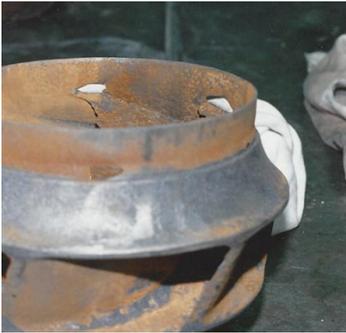
The pump had become worn beyond repair and was thus tossed in a scrap pile.

- * Damaged impeller showing holes ,
- * Worn impeller vanes ,
- * Impeller rebuilt with Belzona 1311 ,
- * Completed application with two coats of Belzona 1341 ,

The application was carried out in accordance with Belzona Know-How System Leaflets CEP 1 & CEP 3. Holes and impeller vanes were patched with Belzona 1311 and a reinforcing sheet. The high spots were ground down to smooth the surface and Belzona 1341 was brushed on in two coats.
