BELZONA REPAIRS FAN BLADES

ID: 5369

Industry: Power
Application: FBC-Fans, Blowers and Compressors

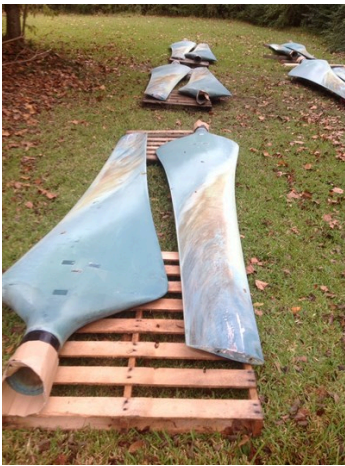
- * Damaged blades before the repair ,
- * Leading edges repaired ,
- * Application completed ,

Fan blades on cooling tower seeing wear on leading edges reducing efficiency.

The application was carried out in accordance to Belzona Know-How System Leaflet FBC-1. Belzona 1111 was used to rebuild the damaged area on the leading edge and Belzona 1321 was applied to the edge for erosion protection. The body of the blades were

coated with Belzona 5811 and overcoated with Belzona 5111.
