# BELZONA REPAIRS FAN BLADES

ID: 5369

Industry: Power  
Application: FBC-Fans, Blowers and Compressors

Customer Location: Houston, Texas, USA  
Application Date: March 2013

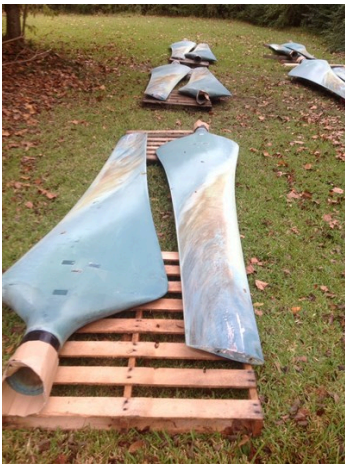
- \* Damaged blades before the repair ,
- \* Leading edges repaired ,
- \* Application completed ,

Fan blades on cooling tower seeing wear on leading edges reducing efficiency.

The application was carried out in accordance to Belzona Know-How System Leaflet FBC-1. Belzona 1111 was used to rebuild the damaged area on the leading edge and Belzona 1321 was applied to the edge for erosion protection. The body of the blades were

coated with Belzona 5811 and overcoated with Belzona 5111.
