# Keeping the Pilots Afloat with Belzona

Industry: Marine  
Application: TCC-Tanks and Chemical Containment Areas  
Substrate: Aluminium  
Products: \* Belzona® 1111 (Super Metal) ,

Customer Location: Docks and Harbour Authority - UK  
Application Date: May 2005

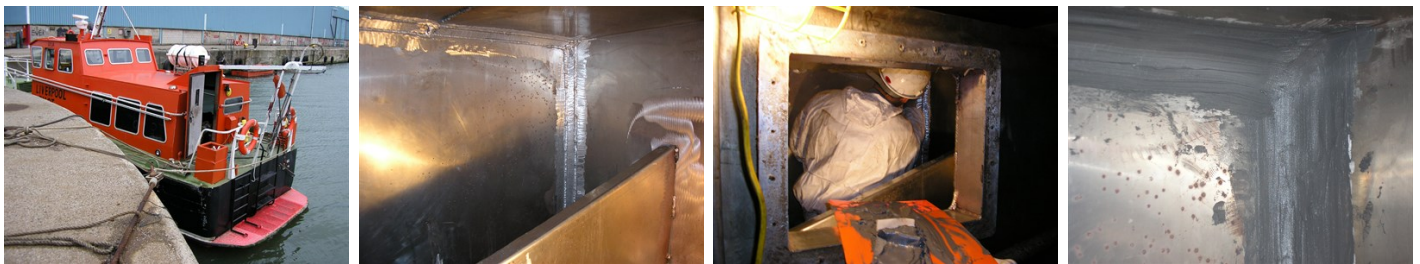
*The folded and welded seams of the Aluminium tank had become porous, allowing diesel fuel to leak out.*

- \* The pilot vessel docked. ,
- \* Preparation and detail of weld seam. ,
- \* The Belzona being applied. The restricted working area is evident. ,
- \* Detail of the finished repair. ,

Belzona was chosen as a means of providing an effective, long lasting repair. Alternatives would have been to try to weld the damaged areas but as it was the weld seams that were leaking and there was very tight access this was deemed impractical. There was also the contamination and presence of diesel to contend with which further ruled out the use of any hot work. The repair was carried out over the course of two days to allow for full curing of the material before pressure testing and then returning the vessel to service.
