FORMING FLAT FLANGE FACES ON A VENTURI WITH BELZONA

ID: 5371

Customer Location: British Columbia, CA

Application Date: July 2014

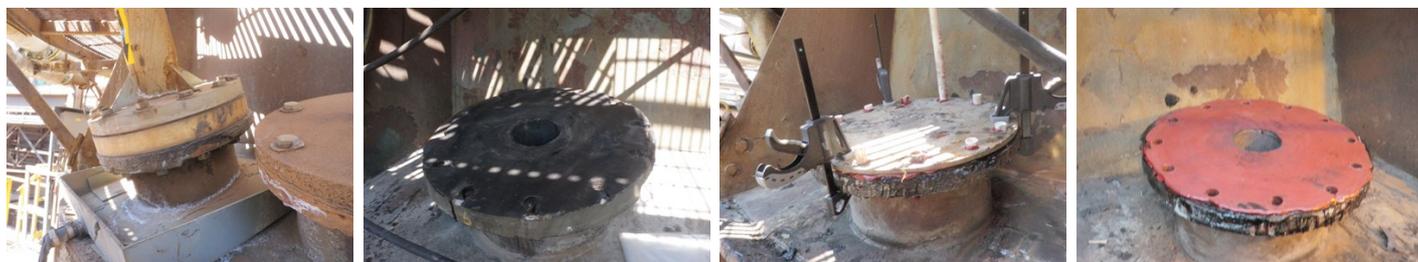
Photograph Descriptions

- * Flange on neighbouring unit in service; one year after rebuild, there is zero leakage in any of the 10 repaired flanges. Note the catch basin under the flange; the Belzona repair has made these redundant and they are being removed Original trial flange is still in excellent condition after two years in service ,
- * Forming plate clamped in place, with plastic pipe used to form bolt holes ,
- * Perfectly flat rebuilt surface seats the gasket properly and does not leak ,

Belzona 2111 is applied to the prepared and conditioned surface; Belzona 2121 is applied to a flat metal forming plate (already coated with Belzona 9411), and this plate is clamped into position with plugs inserted into bolt holes. When the plate is later removed, a perfectly flat gasket surface remains. The application was carried out in accordance with Belzona Know-How System Leaflet GSS-1.
