BELZONA REPAIRS A VACUUM PUMP

ID: 5375

Customer Location: British Columbia, CA
Application Date: August 2014

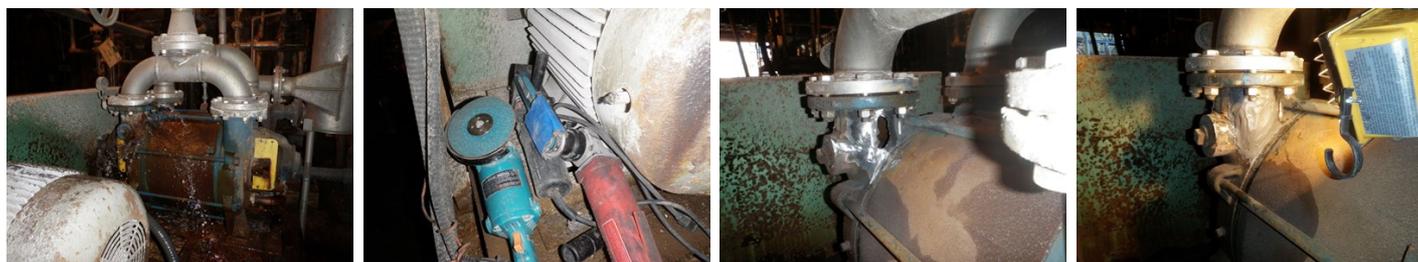
Photograph Descriptions

The outlet port had corroded to the point a hole had formed; a competitor's patch product had been applied but failed after a short time.

- * 1. Image of the leak ,
- * 2. The surface preparation requires a number of tools due to the tight space ,
- * 3. Exposed hole is a bit larger than expected ,
- * 4. The application complete ,

The application was carried out in accordance with the Belzona Know-How System Leaflet CEP-6.
