# Belzona repairs crude oil leaks

ID: 5376

Industry: Oil & Gas  
Application: VPF-Valves, Pipes and Fittings  
Substrate: Carbon Steel  
Products: \* Belzona 1221 (Super E-Metal) ,  
\* Belzona 1161 (Super UW-Metal) ,

Customer Location: Houston, Texas, USA  
Application Date: November 2013

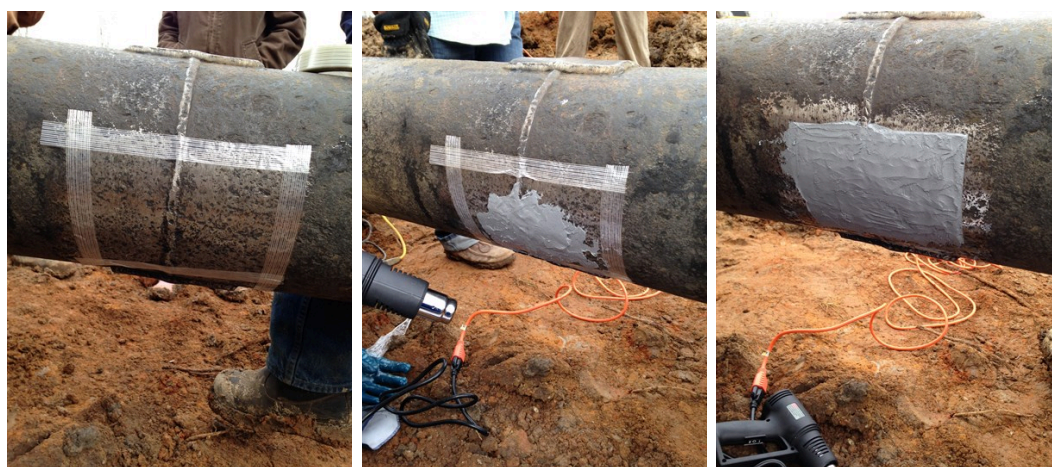
After testing a newly installed line, the customer found a pinhole leak at a weld. Hot work was not permitted because crude oil was now in the line.

- \* Cleaning of the immediate area ,
- \* Belzona 1221 was used to stop leak ,
- \* Belzona 1161 used to encapsulate for long term protection ,

Pinhole leak at weld on a crude oil line.

The application was carried out using a modified version of Belzona Know-How System Leaflet VPF-11. Belzona 1221 was used to stop the immediate leak. The area surrounding the leak was then prepared and Belzona 1161 was applied for long term protection.

To purge the line in order to weld would have taken days and thousands of dollars, the Belzona repair was made in less than an hour and the customer was up and running the same day.
