BELZONA WORKS WHEN THE HEAT IS ON

Industry: *Steel & Metal Processing*
Application: *HEX-Heat Exchangers*
Substrate: *Steel*
Products: ** Belzona 1251 (HA-Metal) ,*

Customer Location: *Smelter, British Columbia, CA*
Application Date: *September 2014*

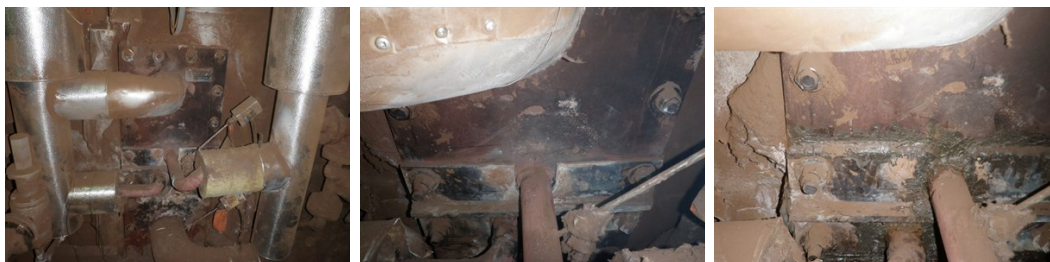
Photograph Descriptions

Leaks had formed around a set of plates used to support cooling coils where they pass through the wall of the roaster.

* 1. Insulation stripped to expose the area; the plates vary from 200°F to 330°F and the exposed piping is over 450°F.
2. The leak is coming from behind the center plate, especially the end at the LH side. 3. Completed application; the center plate is sealed. Please note the Belzona product on the left end of the plate where a bolt was inserted and extra material was required to seal this live leak of hot SO₂ gas. ,

The gap between two of the plates was sealed using Belzona 1251. The area to be repaired was cleaned with a hand-held wire brush. Then, Belzona 1251 was applied with a metal spatula onto the hot surface (temperature varied from 200°F to 330°F depending on location). In the area of the worst leak, Belzona 1251 was applied to reduce the hole size to approximately ¼" and a small bolt was then packed with Belzona 1251 and inserted. The bolt head was then covered with a cap formed of thin metal sheet, filled with Belzona 1251, and held in place until the product set. This repair was performed with the unit active and specialized PPE was worn accordingly. The application was carried out in accordance with a modified version of Belzona Know-How System Leaflet HEX-5.
