# Belzona Repairs to Cement Fan Shaft

ID: 538

Customer Location: Cement manufacturer - Egypt  
Application Date: April 2005

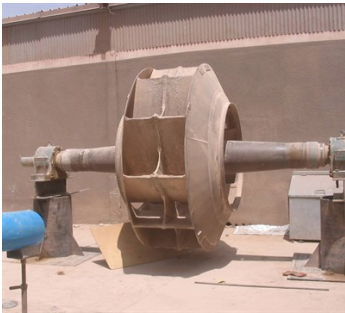
- \* General view of the fan shaft ,
- \* The worn out shaft ,
- \* Form was applied ,
- \* Application was completed ,

Cement fan shaft

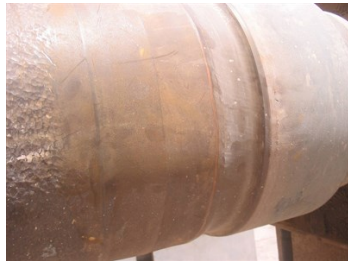
Deeply worn shaft due to abrasion from cement - leading to potential bearing failure.
