# BELZONA REPAIRS A 40-YEAR OLD IRRIGATION PUMP

Application: CEP-Centrifugal Pumps

40-year old 5-stage irrigation pump.

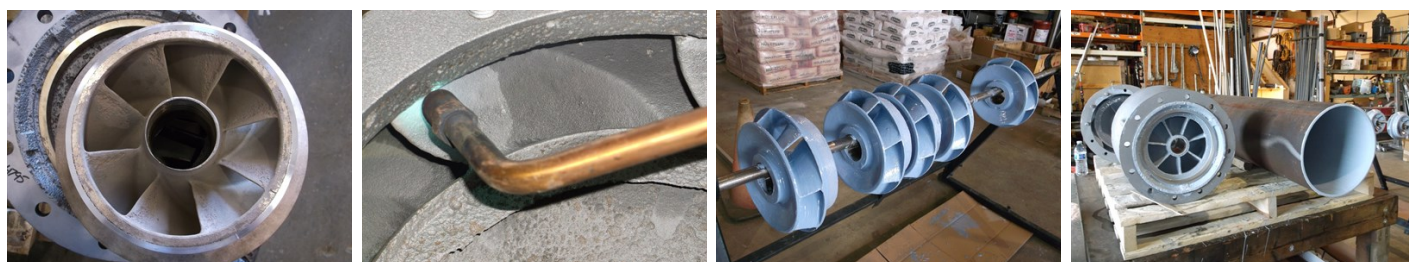
## Photograph Descriptions

*Pump had decreased productivity. It has not been pulled since it was installed in 1974.*

- \* 1. Damaged pump bowl and impeller ,
- \* 2. Sweating the bowl prior to blasting ,
- \* 3. All 5 impellers completed ,
- \* 4. Two of the bowls and suction pipe completed ,

All surfaces to be coated were properly grit blasted to a near white finish. The parts were washed down with a non-chlorinated cleaner. Areas of extreme pitting or cavitation were repaired using Belzona 1221. The first coat of Belzona 1341 was then applied, with the second coat being applied the following day. Applications was carried out in accordance with Belzona Know-How System Leaflets CEP-1 & CEP-10.
