BELZONA REPAIRS A 40-YEAR OLD IRRIGATION PUMP

Application: CEP-Centrifugal Pumps

40-year old 5-stage irrigation pump.

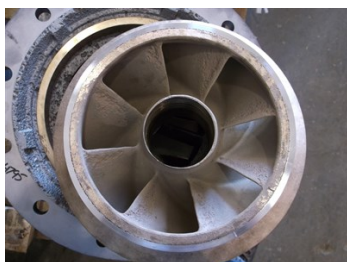
Pump had decreased productivity. It has not been pulled since it was installed in 1974.

- * 1. Damaged pump bowl and impeller ,
- * 2. Sweating the bowl prior to blasting ,
- * 3. All 5 impellers completed ,
- * 4. Two of the bowls and suction pipe completed ,

All surfaces to be coated were properly grit blasted to a near white finish. The parts were washed down with a non-chlorinated cleaner. Areas of extreme pitting or cavitation were repaired using Belzona 1221. The first coat of Belzona 1341 was then applied, with the second coat being applied the following day. Applications was carried out in accordance with Belzona Know-How System Leaflets CEP-1 & CEP-10.
