BELZONA KEEPS A TRANSFORMER IN SERVICE

ID: 5382

Industry: Power
Application: FBC-Fans, Blowers and Compressors

Customer Location: Lewiston, ID, USA
Application Date: May, 2014

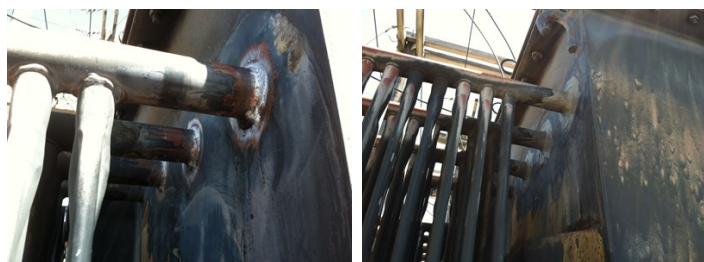
Photograph Descriptions

Welds on the circulation pipes of an electrical transformer were leaking oil, causing an environmental hazard, as well as a mechanical problem, and loss of oil which is essential to proper operation of transformers.

- * 1. Leaking welds on the circulation pipes ,
- * 2. Application completed ,

The application was carried out in accordance with a modified version of Belzona System Leaflet FBC-6. A grinder was used to prepare the surface, then Belzona 1161 was used to seal the seeping leak.
