# BELZONA REBUILDS RUDDER PINTLE HOUSING

ID: 5388

Rudder pintle housing

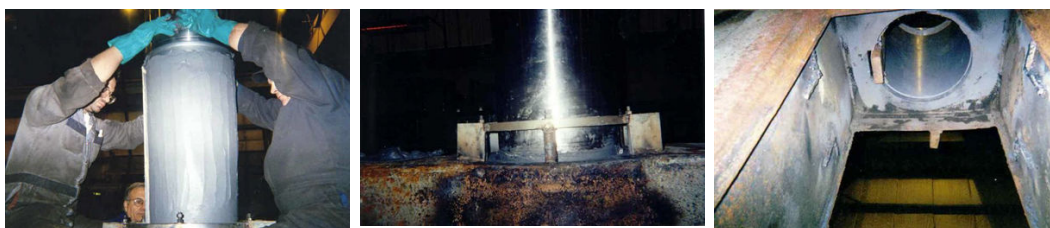
*Rudder pintle housing was badly eroded /corroded and required rebuilding.*

- \* View of rudder pintle liberally coated with Belzona 1311. ,
- \* Pintle fully inserted and centered using a jig tack welded to the top of the rudder. ,
- \* Completed application. Note finish of newly formed bore. ,

Repairing the pintle housing using Belzona 1311 eliminates the probability of developing stress cracks and can be completed in less time. The repair also eliminates the possibility of bi-metallic corrosion taking hold again as it isolates the two metals present in the housing assembly.
