# Belzona Repairs Vacuum Pump

Customer Location: Large Phosphate production facility -  
Egypt

Application: CEP-Centrifugal Pumps

Vacuum pump

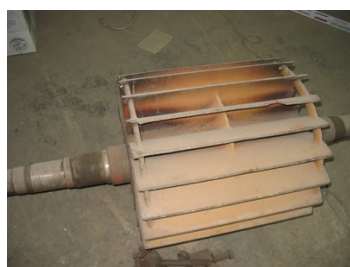
Eroded-corroded rotor and casing due to the effect of water, chemicals and limestone. The vanes of the rotor were cracked and fractured in many places.

- \* The eroded-corroded rotor ,
- \* Repairs to cracks and fractures in the vanes of the rotor ,
- \* Rotor after repairing and coating. ,
- \* Casing after repairing and coating ,

The application was carried out in accordance with Belzona® Know-How System Leaflets CEP-1 and CEP-3.
