Belzona Successfully Repairs Vacuum Pump

Customer Location: Large Phosphate production facility - Egypt

Application: CEP-Centrifugal Pumps

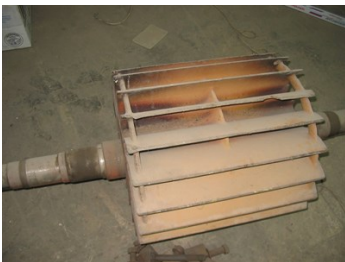
Eroded-corroded rotor and casing due to the effect of water, chemicals and limestone. The vanes of the rotor were cracked and fractured in many places.

- * The eroded-corroded rotor ,
- * Repairs to cracks and fractures in the vanes of the rotor ,
- * Rotor after repairing and coating. ,
- * Casing after repairing and coating ,

The application was carried out in accordance with Belzona® Know-How System Leaflets CEP-1 and CEP-3.
