Belzona Successfully Repairs Vacuum Pump

Customer Location: Large Phosphate production facility - Egypt

Application: CEP-Centrifugal Pumps

Vacuum pump

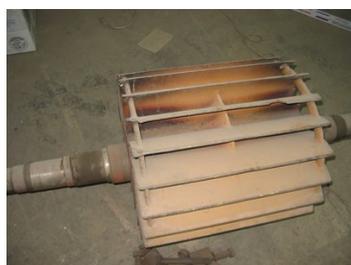
Eroded-corroded rotor and casing due to the effect of water, chemicals and limestone. The vanes of the rotor were cracked and fractured in many places.

- * The eroded-corroded rotor ,
- * Repairs to cracks and fractures in the vanes of the rotor ,
- * Rotor after repairing and coating. ,
- * Casing after repairing and coating ,
