BELZONA IMPROVES WORKING CONDITIONS BY SEALING THE ROOF OF A CHOCOLATE FACTORY

Application: RPA-Roof Problem Areas

Substrate: Rubber

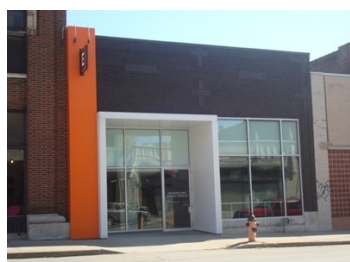
- * Storefront image ,
- * The roof prepared and ready for application ,
- * Picture of the first 1/2 of sprayed Belzona 3111 ,
- * Picture of finished installation of Belzona 3111, including repaired parapets ,

The roof was pressure washed and the parapets were re-pointed with Belzona 4111. The roof was then completely sealed and protected with the Belzona 3111 system. The application was carried out in accordance with a modified version of Belzona System Leaflet RPA-10.
