# Belzona Rebuilds and Protects Severely Corroded Pump

ID: 540

Customer Location: *Cargo ship in a marine shipyard - Egypt*  
Application Date: *April 2004*

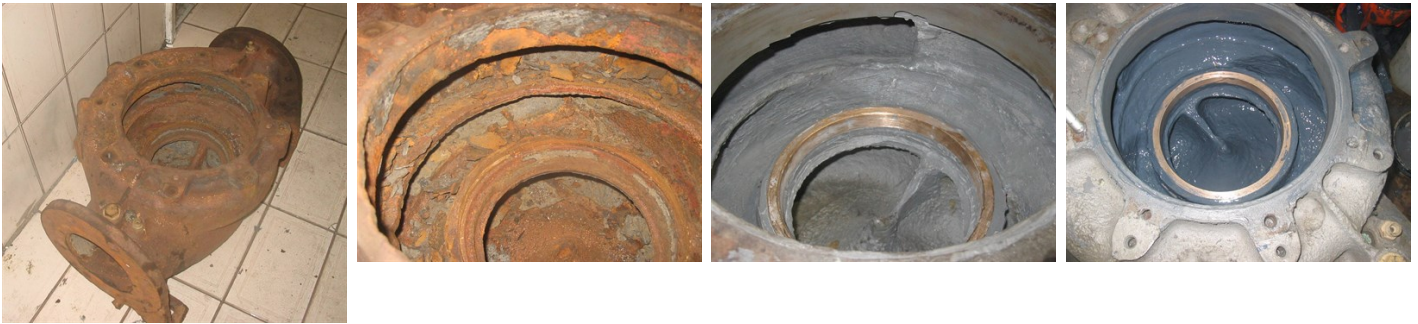
*Severe corrosion and erosion inside the pump that led to many holes in the pump casing.*

- \* General view of the corroded pump ,
- \* The pump from inside before repair ,
- \* Rebuilding the worn out part of the pump after repairing the holed areas ,
- \* Belzona® 1321 was applied to protect the pump ,

The application was carried out in accordance with Belzona Know-How System Leaflets CEP-1, CEP-3 and CEP-5.

Belzona repairs and protects even such worn out pump returning it to service as quickly as possible saving the cost of a new unit whilst also giving it increased resistance to the effects of erosion-corrosion.
