Belzona Rebuilds and Protects Severely Corroded Pump

ID: 540

Industry: *Marine*
Application: *CEP-Centrifugal Pumps*
Substrate: *Cast iron*
Products: ** Belzona® 1311 (Ceramic R-Metal) ,*
** Belzona® 1321 (Ceramic S-Metal) ,*

Customer Location: *Cargo ship in a marine shipyard - Egypt*
Application Date: *April 2004*

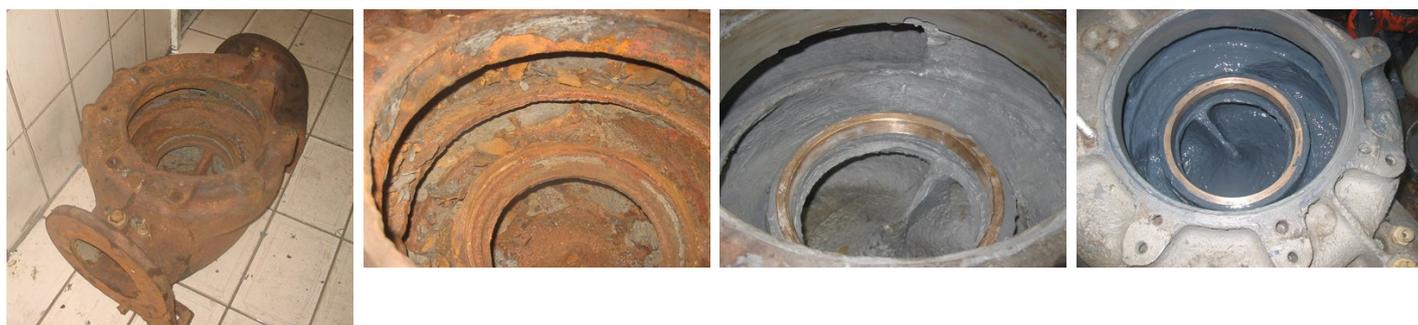
Photograph Descriptions

Severe corrosion and erosion inside the pump that led to many holes in the pump casing.

- * General view of the corroded pump ,
- * The pump from inside before repair ,
- * Rebuilding the worn out part of the pump after repairing the holed areas ,
- * Belzona® 1321 was applied to protect the pump ,

The application was carried out in accordance with Belzona Know-How System Leaflets CEP-1, CEP-3 and CEP-5.

Belzona repairs and protects even such worn out pump returning it to service as quickly as possible saving the cost of a new unit whilst also giving it increased resistance to the effects of erosion-corrosion.
