# BELZONA PROTECTS RUDDERS

ID: 5401

Rudders

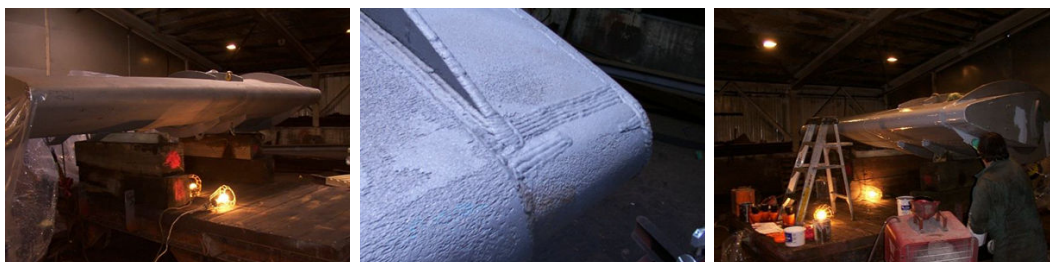
*The rudders suffer from serious cavitation problems.*

\* 1. Rudder after grit blasting 2. Excessively cavitated areas are rebuilt with Belzona 1311 before being over coated with Belzona 1341 Supermetalglide. 3. Final coat of Belzona 1341 Supermetalglide (Grey) applied and force cured with heat lamps to meet deadline. ,

Application carried out in accordance with Belzona Know-How System Leaflet SOS 1,2

Application of Belzona 1341 Supermetalglide will help reduce the effects of cavitation between dry dockings.
