# BELZONA STOPS WATER LEAKING INTO AIRCRAFT HANGAR

ID: 5402

Customer Location: MO, USA  
Application Date: November, 2004

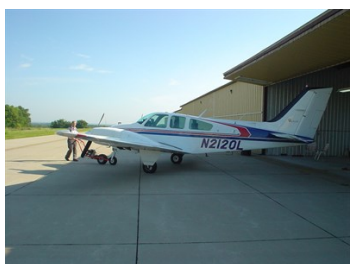
- \* 1. Picture of airplane hangar ,
- \* 2. Damaged flashing and area of penetration ,
- \* 3. Berm built to direct water away from the door ,
- \* 4. Picture of completed repair ,

The flashing was re-secured to the asphalt with mechanical fasteners. Two coats of Belzona 3121 was then applied a few inches above the flashing and down onto the asphalt. Also, a small berm was fabricated with Belzona 4111 to divert run-off water away from the door.

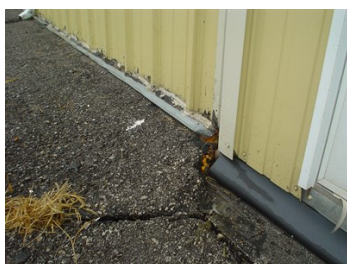
*This hangar at a municipal airport was leaking water into aircraft hangars due to the damaged flashing and creating a slip hazard near the entry door. Mastics and caulk had failed and a more permanent solution was needed.*

Damaged outer wall flashing of an airplane hangar.
