# BELZONA PROTECTS CONTAINMENT AREA AT A TREATMENT PLANT

ID: 5403

Customer Location: Monroe, WA, USA  
Application Date: November 2012

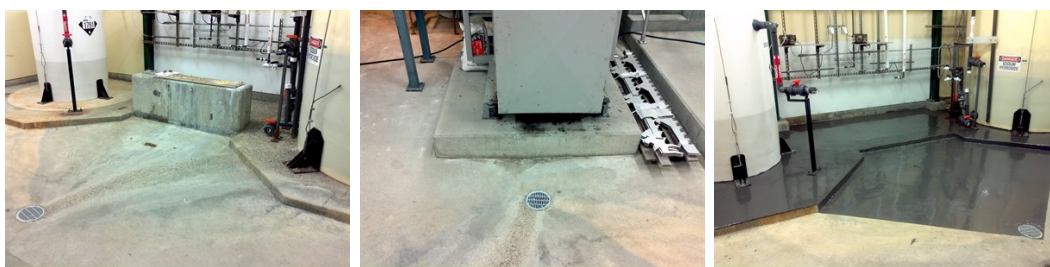
Spalled floor areas needed repair and coating to prevent further damage and provide secure containment for potential spillage  
Treatment chemicals stored on concrete pads without protective coating including surrounding floor area and drain. Spalling to floor areas was evident where spillage occurred.

- \* Wastewater plant chemical storage area before repairs & coating ,
- \* Storage drain area spalling ,
- \* Storage area after repairs & coating ,

The application was carried out in accordance with Belzona Know-How System Leaflets FPA-1, FPA-3. Belzona 4111 was hand troweled over most severely spalled areas prior to hand application of two coats of Belzona 5811
