BELZONA PROTECTS CONTAINMENT AREA AT A TREATMENT PLANT

ID: 5403

Industry: Water / Wastewater

Customer Location: Monroe, WA, USA

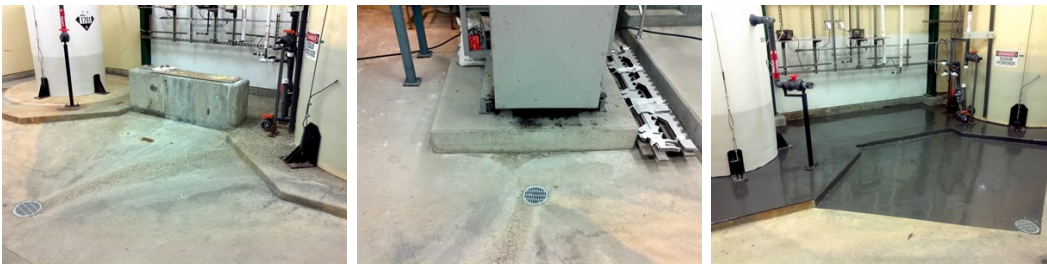
Photograph Descriptions

Spalled floor areas needed repair and coating to prevent further damage and provide secure containment for potential spillage
Treatment chemicals stored on concrete pads without protective coating including surrounding floor area and drain. Spalling to floor areas was evident where spillage occurred.

- * Wastewater plant chemical storage area before repairs & coating ,
- * Storage drain area spalling ,
- * Storage area after repairs & coating ,

The application was carried out in accordance with Belzona Know-How System Leaflets FPA-1, FPA-3. Belzona 4111 was hand troweled over most severely spalled areas prior to hand application of two coats of Belzona 5811
