BELZONA PROTECTS ASH SLURRY TANK

ID: 5405

Industry: Power
Application: TCC-Tanks and Chemical Containment Areas
Substrate: Blast cleaned carbon steel
Products: * Belzona 1321 (Ceramic S Metal) ,

Customer Location: Lynnwood, WA, USA
Application Date: June 2008

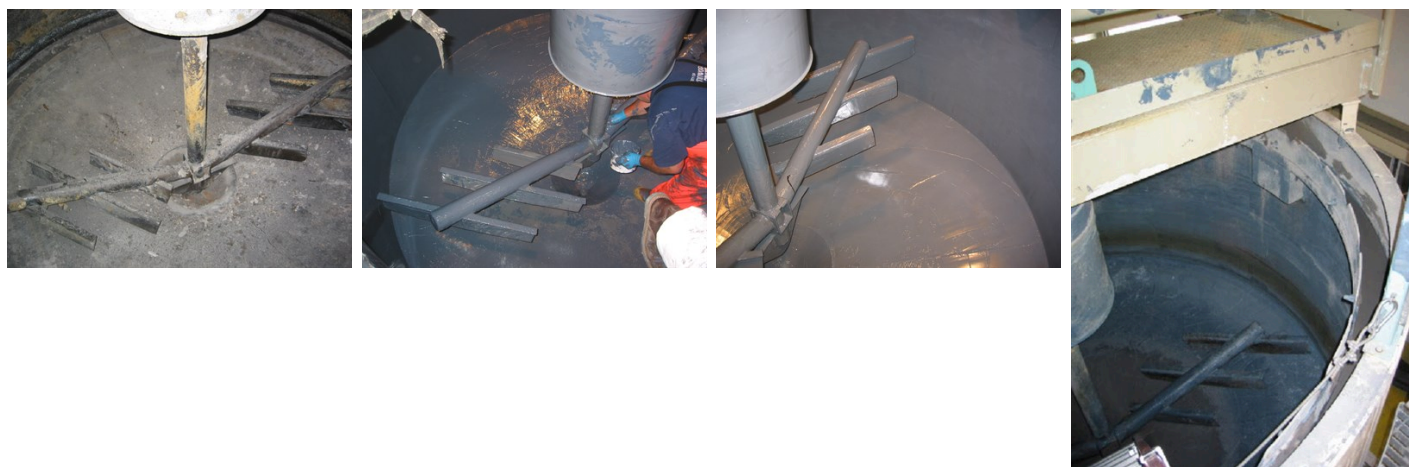
Photograph Descriptions

Customer looking for a proven coating to protect the life of their ash slurry tank. The tank receives solids in slurry at elevated temperatures from plant incinerator. Abrasion is noted problem with this component

- * Ash slurry tank before coating ,
- * Ash slurry tank during second coat application ,
- * Ash slurry tank after coating ,
- * Two years after above application ,

The application was carried out in accordance with Belzona Know-How System Leaflet TCC-3. Two heavy coats of Belzona 1321 were hand troweled and brushed onto all interior surfaces of tank and agitator.
