Circulating Water Pump Repair

ID: 541

Customer Location: Power station, Egypt
Application Date: July 2004

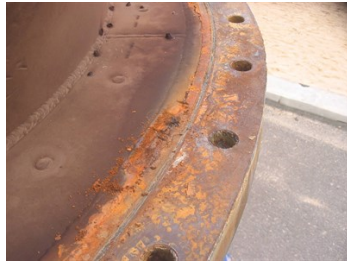
Galvanic corrosion between the cast iron of the discharge casing and the welded stainless steel sheet.

- * General view of the pump ,
- * The corroded discharge casing ,
- * Applying Belzona® 1311 to the prepared surface ,
- * Application complete ,

Application was carried out in accordance with Belzona Know-How System Leaflet CEP-5.
