# BELZONA REPAIRS DRILLING MACHINE THREAD

ID: 5411

## Problem

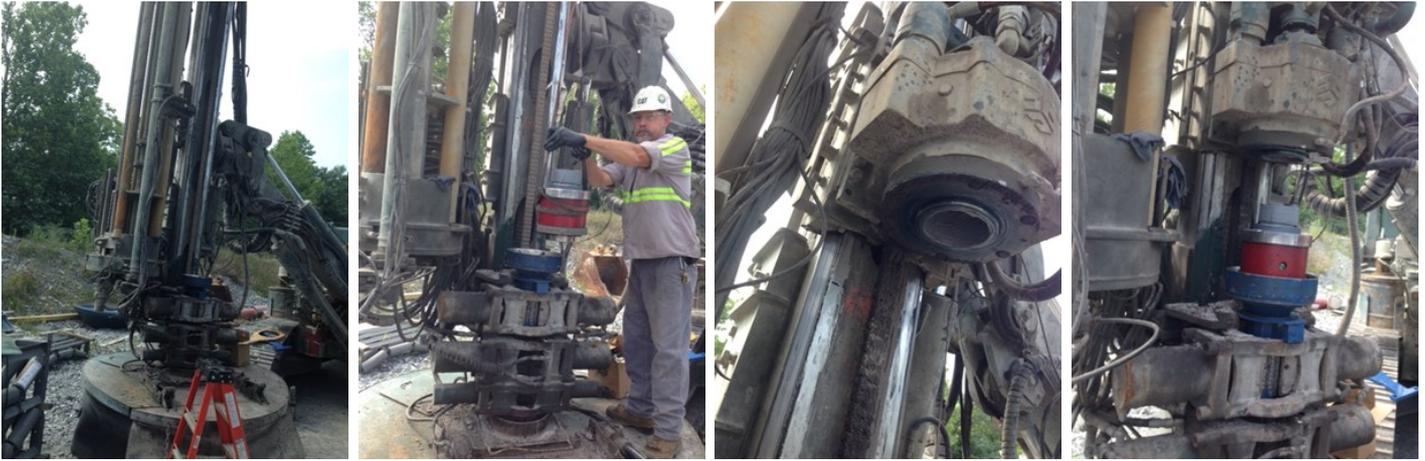
*Worn threads on drilling machine would not allow the drill to seal properly, allowing water to leak and lose water pressure.*

- \* Overview of the drill ,
- \* Male thread being placed underneath the female piece ,
- \* Oversized female thread filled with Belzona 1111 ,
- \* Belzona 1111 applied on male thread prior to placing both pieces together to complete the application ,

Threads on drilling machine were worn.

The threads were cleaned, using a suitable cleaner/degreaser and a wire brush on the female threads. A release agent was used on a new male thread piece. Belzona 1111 was mixed and applied to both male and female threads. The new piece was screwed into the worn female piece. The excess was wiped off and it was allowed to cure overnight. The new piece was removed in the morning, inspected and then screwed back and sealed. The drill has been constantly used for 2 months now and there are no signs of leakage.
