# BELZONA REPAIRS AND PROTECTS PUMP CASING

ID: 5415

Industry: General Industry  
Application: CEP-Centrifugal Pumps  
Substrate: Cast Iron  
Products: \* Belzona 1111 (Super Metal) ,  
\* Belzona 1341 (Supermetalglide) ,

Customer Location: BC, Canada  
Application Date: July 2002

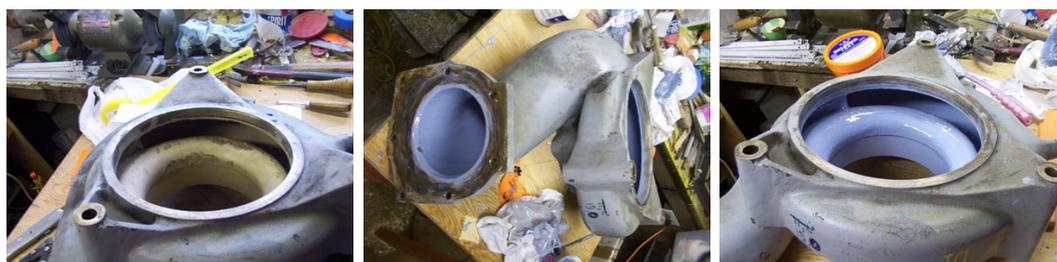
Pump casing was showing signs of degradation. This was from possible contamination during casting process.

- \* View of casing showing damaged areas requiring rebuilding. ,
- \* Application of 1st coat of Belzona 1341 in progress ,
- \* Completed application. ,

The application was carried out in accordance with Belzona Know-How System Leaflet CEP-3, CEP-5.

A Belzona repair allowed the damaged areas to be quickly rebuilt and the casing protected from further bi-metallic erosion.
