# BELZONA REPAIRS AND PROTECTS GASO TREATER

ID: 5420

Heavy Gas treatment vessels in a refinery

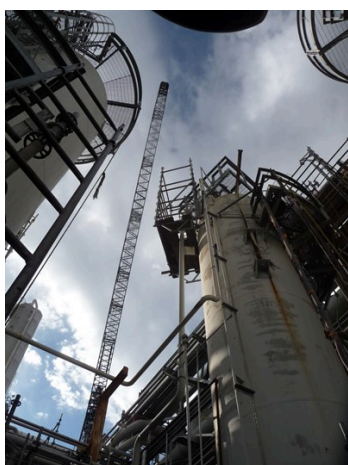
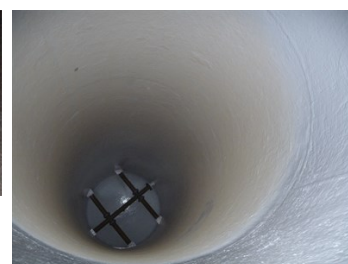
Corrosive process environment used in treating Heavy Gas and Natural Gas caused excessive pitting to vessel walls. Not only did coating have to stand up to this environment it needed to withstand steam out approaching 400F.

- \* Vessel exterior ,
- \* Vessel floor and wall ,
- \* Close up of pitting ,
- \* Finished project ,

Application was carried out in accordance with a specific Method Statement developed for this project which included Belzona Know-How System Leaflet TCC-3 for repairing/renewing damaged linings. Belzona 1111 was used for pit filling; Belzona 5892 was applied using a brush as a two coat system in accordance with Belzona Instructions For Use.
